ZERTIFIKAT

Für LAMBDA SYSTEMREINIGUNGSPRODUKTE

Test report

About the effect of Lambda System Cleaning Products

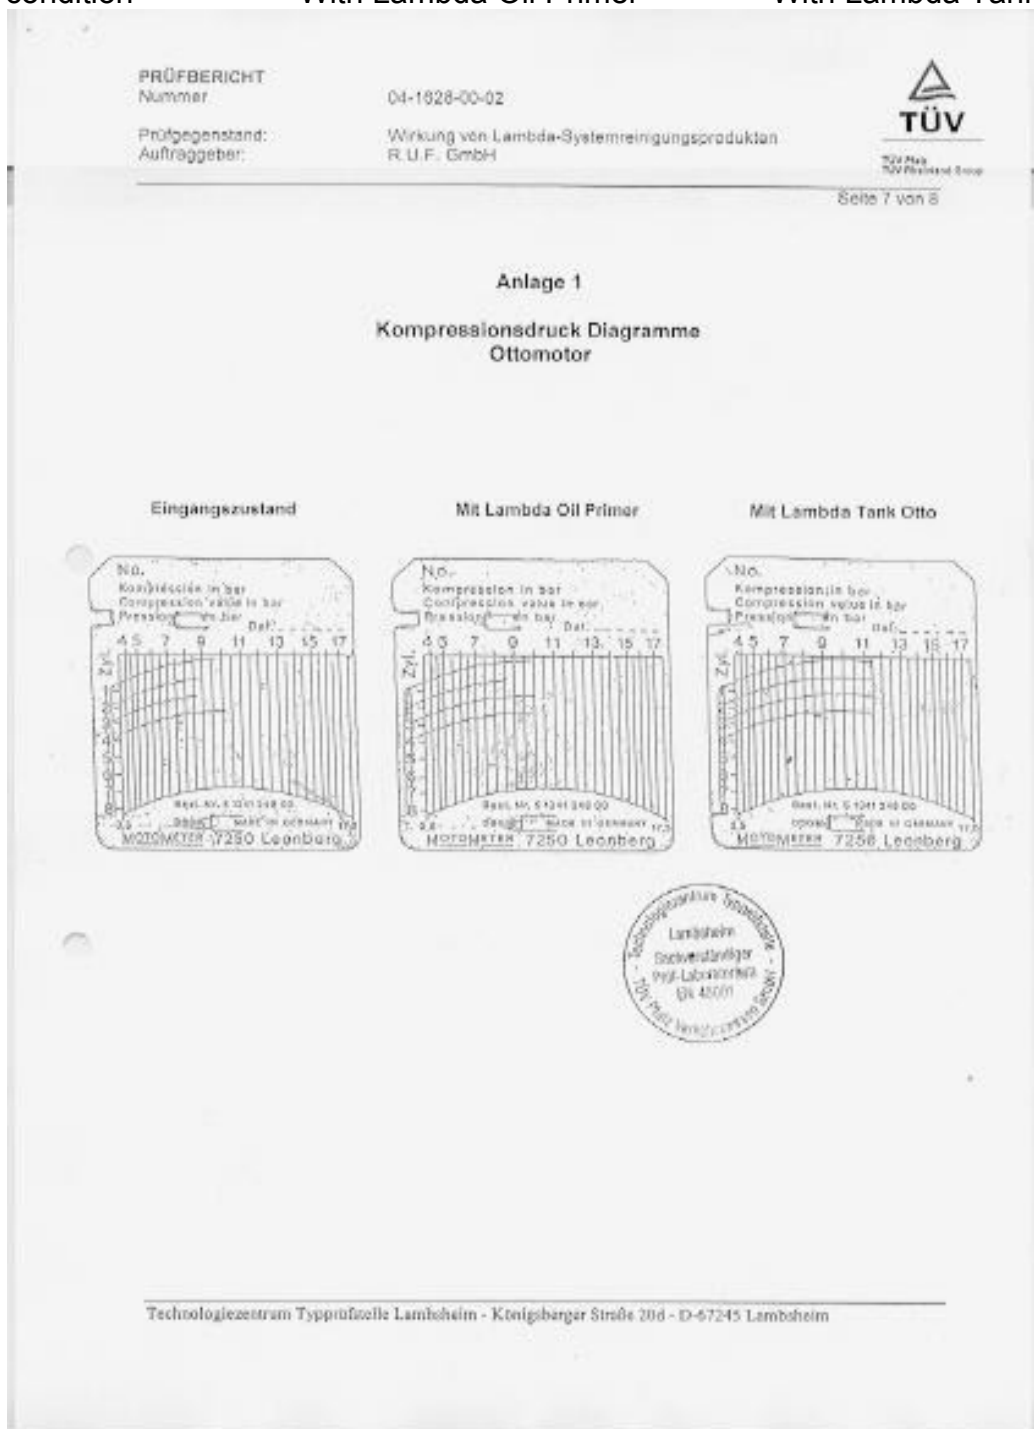
Enclosure 1

Compression pressure diagrams
Otto engine

Initial condition

With Lambda Oil Primer

With Lambda Tank Otto

Compression pressure (bar)				Notes
	Cyl. 1	Cyl. 2	Cyl. 3	Cyl. 4	
Initial condition	9.75	9.00	8.75	10.25	Uneven compression pressure, deviations partly bigger than 1 bar
With Lambda Oil Primer	9.75	8.75	10.00	10.00	Substantial increase of compression pressure at cylinder 3.
Comparison before - after	-	-0.25*	+1.25	-0.25*	Increase of the compression pressure at cylinder 3 caused by effect on the piston rings/piston ring slots.

Compression pressure (bar)				Notes
	Cyl. 1	Cyl. 2	Cyl. 3	Cyl. 4	
Initial condition	9.75	8.75	10.00	10.00	Uneven compression pressure, deviations partly bigger than 1 bar
With Lambda Tank Otto	11.00	11.00	11.5	11.00	Very good, even compression pressure.
Comparison before - after	+1.25	+2.25	+1.5	+1.00	Substantial increase of the compression pressure at all cylinders, caused by effect on the valves and / or piston rings.

Engine oil temperature at all compression pressure measurements: 92 – 96 °C.

Enclosure 1: Compression pressure diagrams Otto engine (1 page)

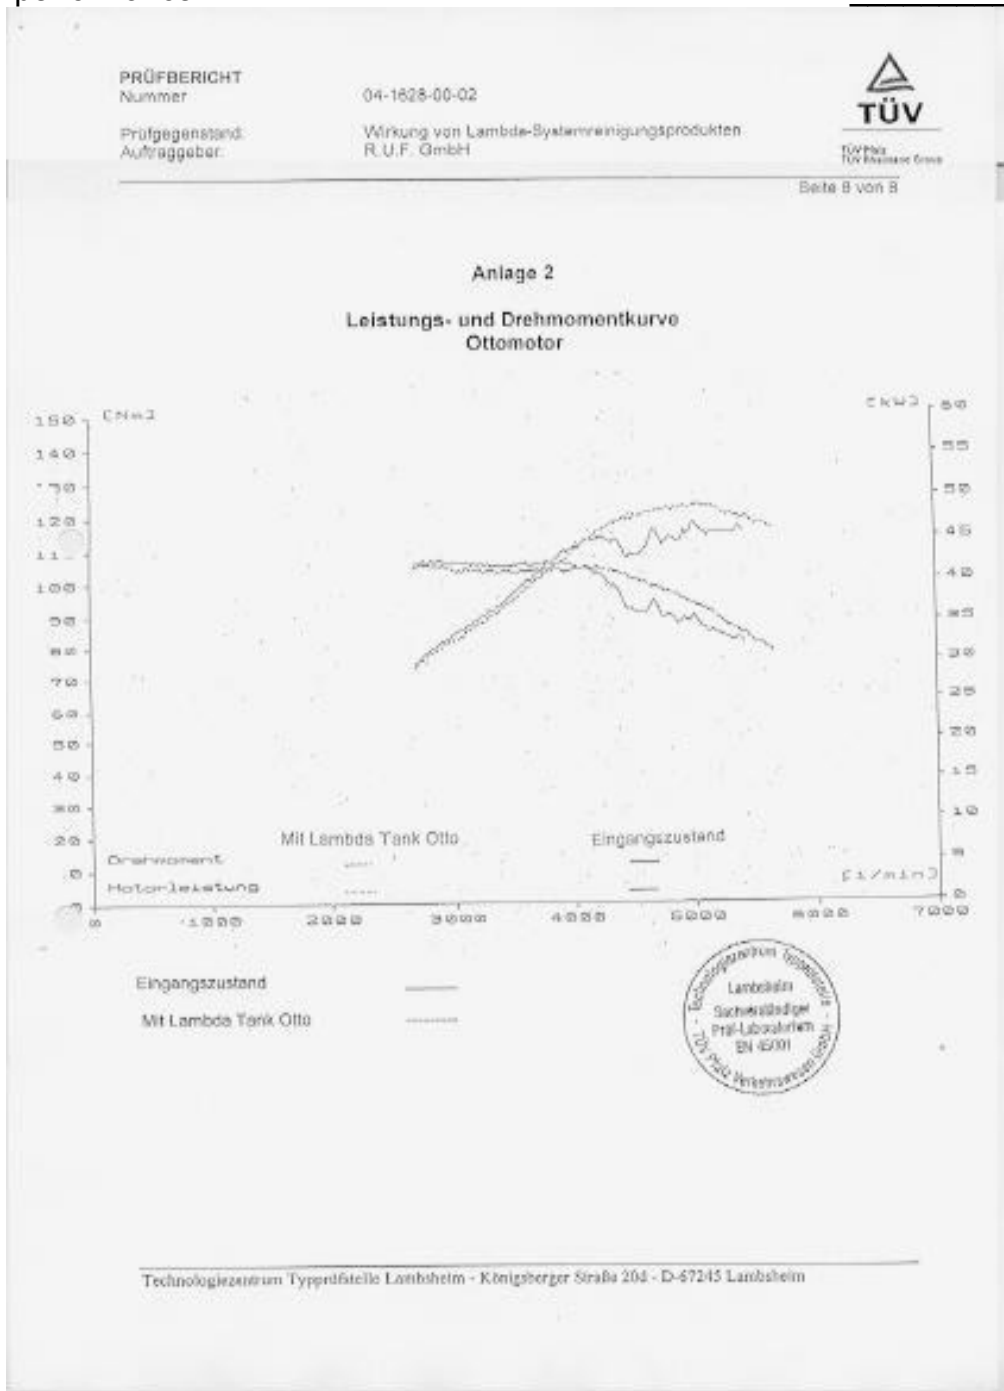
Enclosure 2

Performance and torque curve
Otto engine

Torque
Engine performance

with Lambda Tank Otto

Initial Condition

Initial condition: Between 4,300 – 5,500 min⁻¹ revs per minute, the full load curve of the engine shows a slump with irregular process, which might indicate existing disturbances in the air/fuel mixture, the gas change or the ignition.

In the context of the measuring tolerance no measurable changes in the full load curve of the engine could be recognized.

The slump determined in the initial condition in the full load characteristic in the speed range 4,300 – 5,500 min⁻¹ was eliminated. The maximum power loss amounted 4.4 kW with 4,460 min⁻¹. After the employment of the Lambda Tank Otto, the full load curve is smooth and inconspicuous.

Enclosure 2: Performance curve and torque curve Otto engine (1 page)
